Monitoring Data Record

Project Title: U-2524AB (Site 7 and 17) COE Action ID: 200321137
 Stream Name: UT to Hickory Creek DWQ Number: 030909
 City, County and other Location Information: Greensboro Western Loop, Guilford Co.
 Site 7 (Sta. 11+60 to Sta. 11+67 -40SB REV-) and Site 17 (Sta. 11+00 to Sta. 13+00 -40SB REV-)

Date Construction Completed: Water was turned into the stream on June 2005 and planted in February 2006. Monitoring Year: (4) of 5

Monitoring DATA collected by: M. Green & J. Young Date: 7/29/09

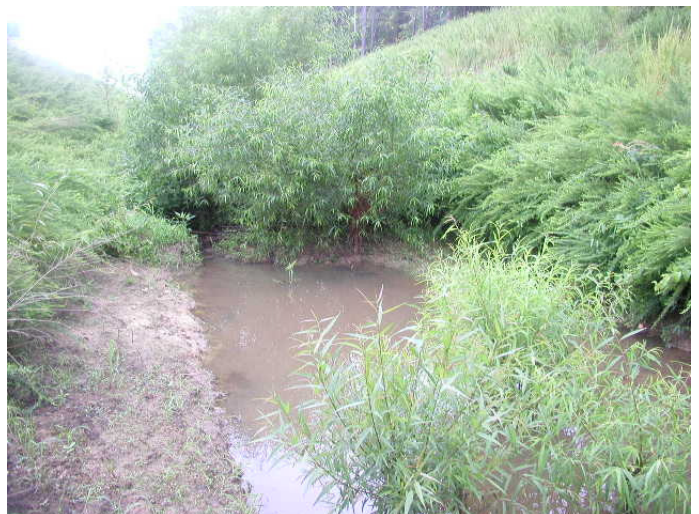
Photo Point #3 (Downstream)

This report is the Year 4 summer evaluation and the channel is stable throughout the entire onsite stream relocation project. The beaver dam located downstream of PP#3, which was noted on last monitoring report, has been breeched so water can flow down stream. NCDOT will continue to monitor this stream relocation.
